DSTO-TR-0423

The Static Testing of a Lockheed P-3  
Orion Wing Leading Edge Centre  
Section

**Airframes and Engines Division  
Aeronautical and Maritime Research Laboratory**

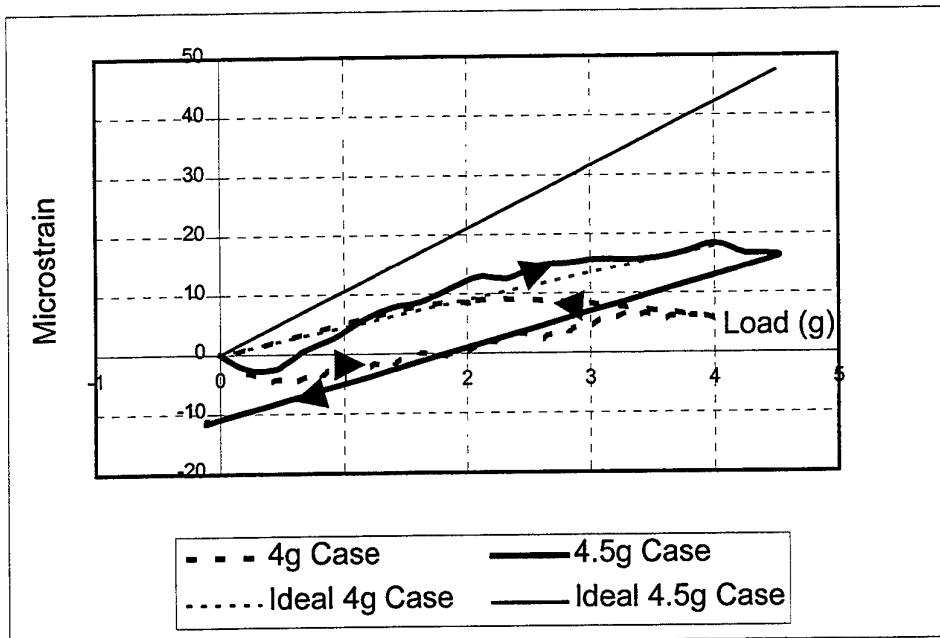
Figure 3. Strain readings on Load Link-2 for both the 4g and 4.5g PLAA cases.

results for Link-2 for the 2 load cases under the PLAA conditions are shown in Fig. 3, where it may be seen that the load link readings deviated from the expected value quite inconsistently. In particular, it may be noted that in both cases, and especially for the 4g case, the strain reading on this link registered negative values over a significant portion of the test range during load up. This clearly indicated the readings to be erroneous as the applied load cannot possibly be negative in such a cable-pull system. Consequently, it must be concluded that the load link results should not be used to infer cable loads. Fortunately, this should not degrade the outcome of the test significantly in that little losses were encountered through the pulley assemblies.

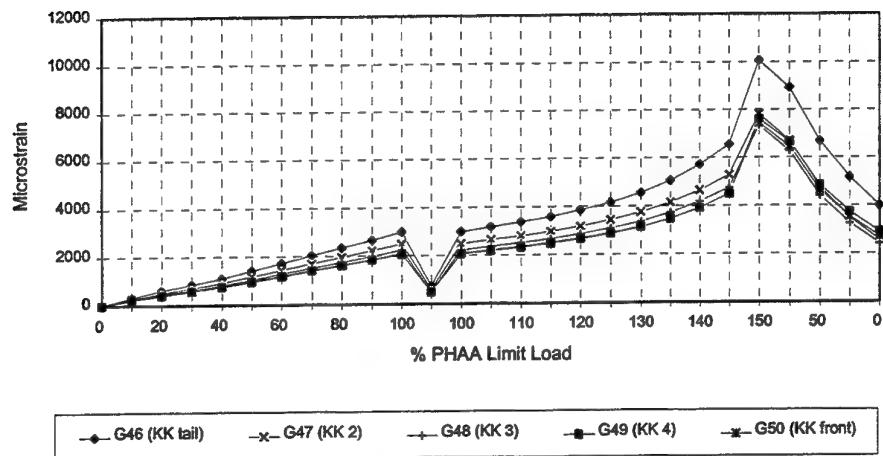
Figure 7. WS273 lower leg strains at critical region for PHAA Test.

The ribs at WS273 and WS317 were also equipped with a 5x1mm strip gauge at the expected critical location (Section KK), and their recorded strains are shown in Figs 7 and 8. As expected the strains here were much higher than those at the other sections (EE, GG, FF). It is interesting to note that, at DUL, the highest recorded strains reached at WS273 (midspan rib) were approx. 10,000 microstrains compared to approx. 3,750 microstrains reached at WS317 (furthest outboard internal rib). The lower strains exhibited by this outboard rib were due mainly to the fact that the rib spacing between this rib and the adjacent outboard closure rib is approximately half of the normal spacing. This evidence does not support the earlier conclusion that the WS317 rib might have been the critical rib (see Callinan *et al* [2]).

Beyond 120%DLL, the Section KK strains at WS273 rapidly increased such that the yield strain of approx. 5,000 microstrains was reached at 135%DLL and proceeded exponentially to approx. 10,000 at DUL. It may also be noted from the table shown in Figs 7 that whilst the residual strain introduced by the DLL loading were insignificant, they were extremely high (approx. 3900 microstrains) as a result of the DUL loads.

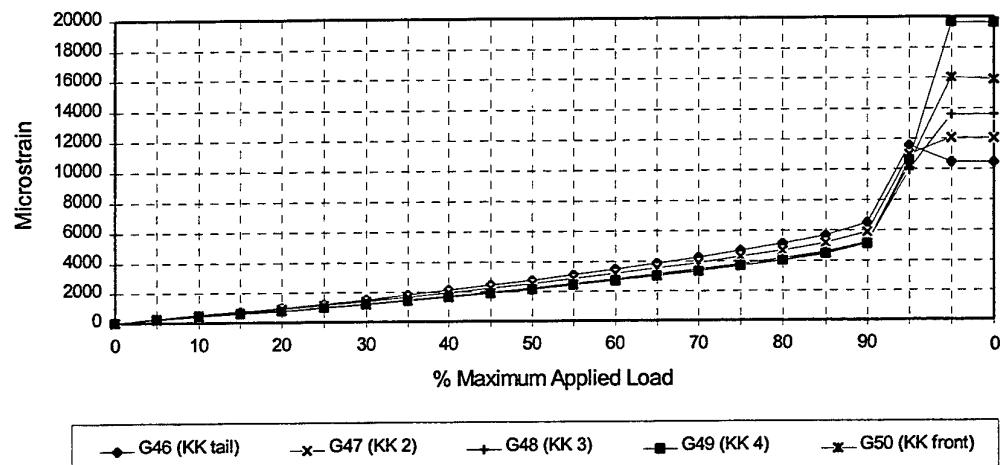
Figure 16. WS273 lower leg strains at critical region for the PLAA Test: a) 4g case, b) 4.5g case.

The lower leg strains of ribs WS228, WS273 and WS317 for the PLAA Test are shown in Figs 14 to 17. As was seen in the previous Section, the tensile strains for the PLAA 4g case were less severe than those seen at DUL under the PHAA condition, but the maximum strains reached at 95% of the 4.5g case were slightly higher. The maximum recorded strains at the critical region (Section KK) for WS273 was 11,571 microstrains just prior to failure.

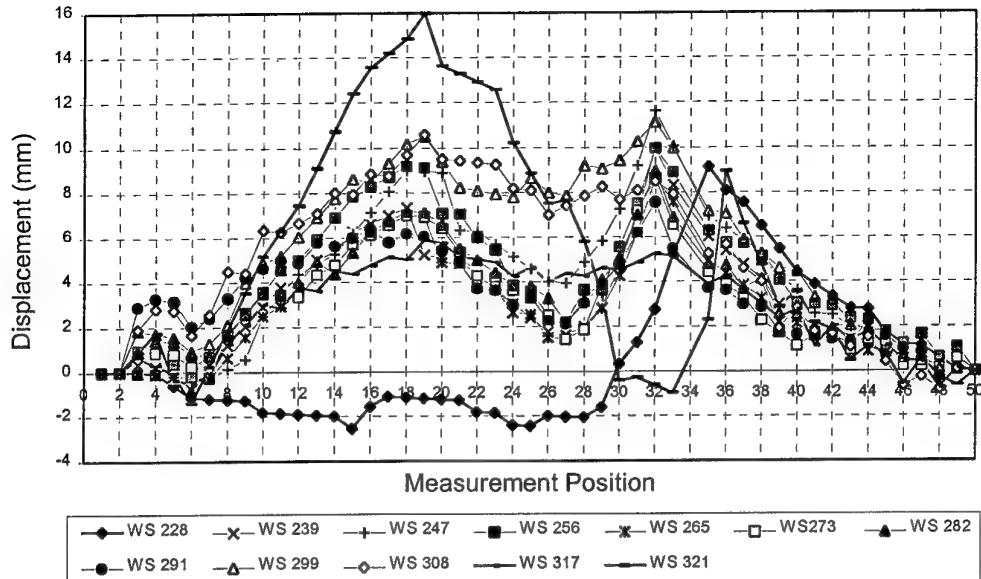
Figure 23. Final rib displacements after failure.

From the strain data, it was seen that at least some parts of the test article had undergone plastic deformation prior to failure. This was also reflected most clearly by the permanent deformation of the ribs at the conclusion of the tests. To quantify this, detailed measurement of the deformed shapes of each rib was carried out. This was achieved by dividing the inner perimeter of each rib into 50 evenly spaced locations and a distance was measured from the centre-line of each rib at these locations to a reference plane mounted on the inboard closure rib WS228. Because the inboard rib is canted, there was a linear component of the measurement associated with this inclination which could be effectively removed. Figure 23 shows the results of the measurements after the canted components were removed. Some of the noteworthy locations are as follows:

It may be seen from the results that most of the ribs deformed similarly, and predominantly in the positive (outboard) direction. There were 2 dominant peaks, namely, one near Position 19 corresponding to the critical location, and one near Position 32 which was the counterpart of the critical location on the upper leg. Some departure from this general trend was seen for the 2 closure ribs (WS228 and WS321), both of which were structured significantly differently from the internal ribs. For the

An interesting feature to note is the sharpness of the deformation peaks on the compressive legs for all ribs, which reflect the sharp folds formed by the compressive collapse of this part of the structure when failure occurred.
